Sixth International Conference on Durability of Concrete Structures
18 - 20 July 2018
University of Leeds, Leeds, West Yorkshire, LS2 9JT, United Kingdom

Paper Number TIM16

Damage Evaluation of Full-Scale RC Slab by Ultrasonic Tomography

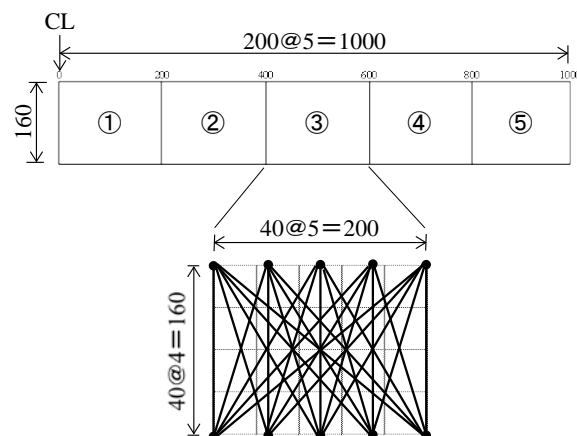
Fig. 5. Analysis cross-section, region for analysis, and division into elements

As shown in the top half of Fig. 5, the region for this analysis, which was 1000 mm in width, was divided into five segments. Each segment was 200 mm in width and 160 mm in height. As shown in the bottom half of Fig. 5, the propagation time for ultrasonic waves was measured in each divided region, in which sources and receivers were set on the top surface and underside of the specimen. The measurements were taken when the bending of the specimen reached the design bending value, which was measured by ignoring the conditions of the tension side concrete, and the wheel running test was stopped. The sensor used for this measurement was the same sensor as that used for measuring the ultrasonic propagation velocity of the sampled cores, which will be discussed later in this report. The reason for dividing the analysis cross section into 5 segments was that even though the ultrasonic waves can detect small internal damage with high accuracy because they have a relatively high frequency, the attenuation of the wave in concrete is great and the propagation distance becomes short in damaged concrete.

Then, as shown in the bottom diagram in Fig. 5, the calculation was done by dividing the area of 200 mm by 160 mm into 20 elements: the width of each 200 mm-segment was divided into 5 and the height of 160 mm was divided into 4. In the expressing the analysis result, smoothing processing was done by subdividing each element into 9.
